Preliminary Engineering Report

Water System Improvements Project
Village of Wellsville, Allegany County, New York

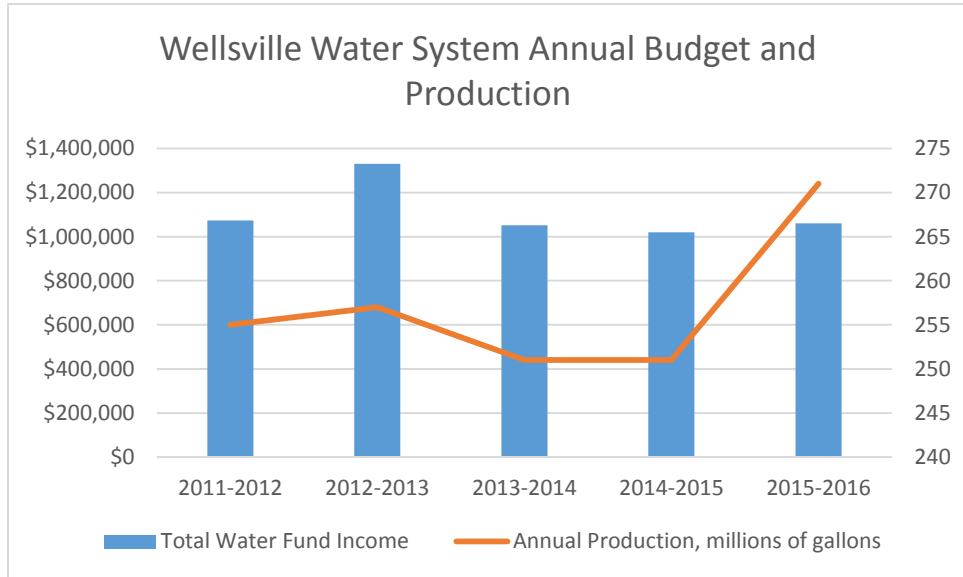
Figure 7: Village of Wellsville Total Water Fund Income, 2011-2016.

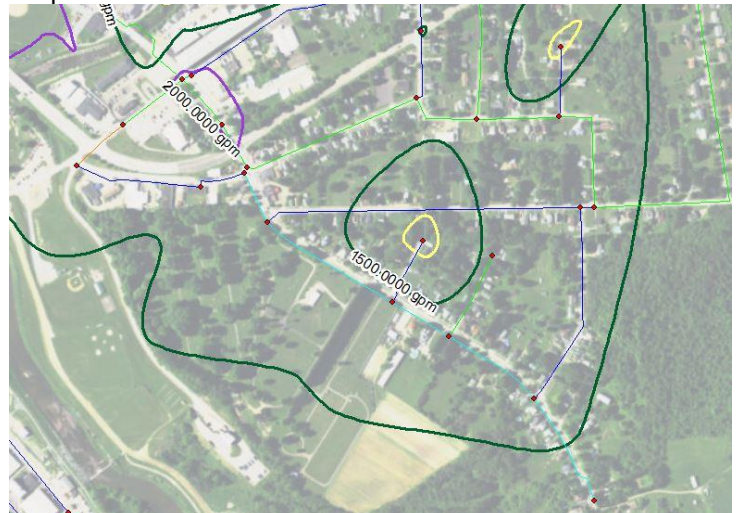
v. West State Street

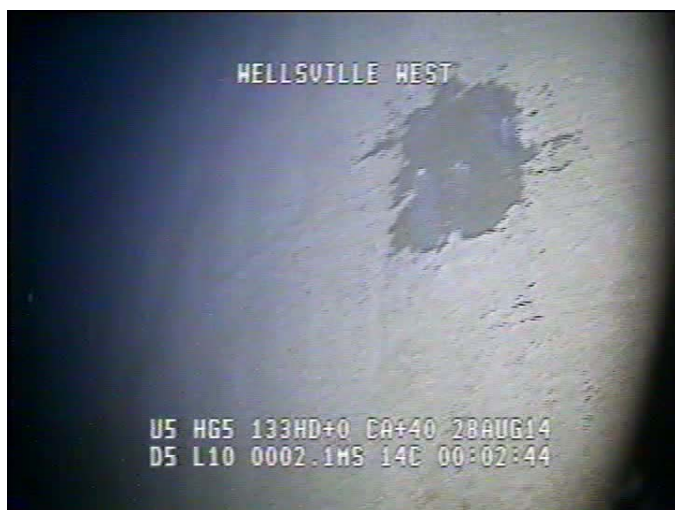
View of coating patch on wall in upper third of tank. Wall appears to be in good condition.

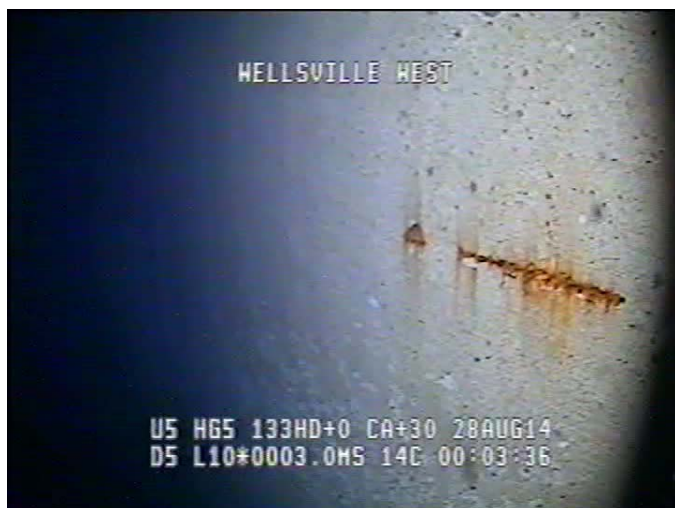
Isolated rusting through wall coating in upper third of tank.

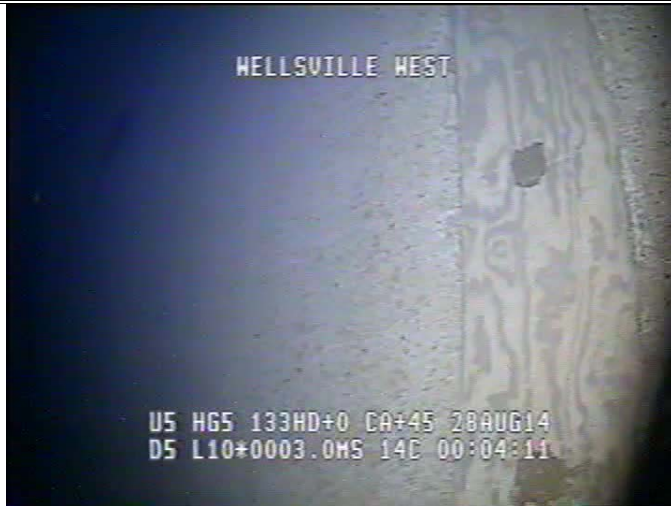
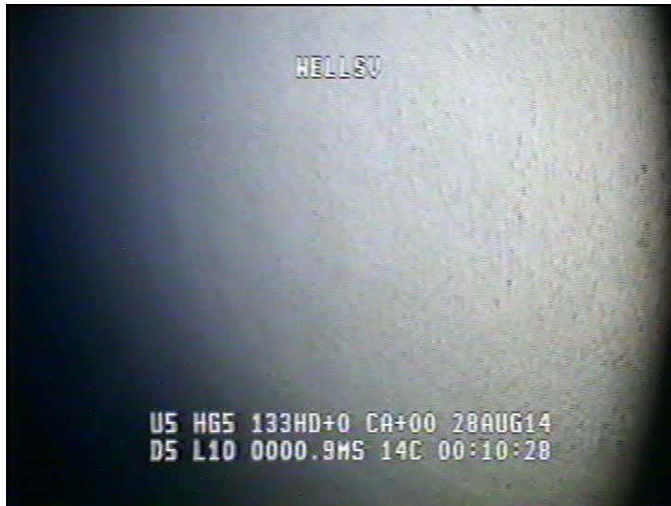
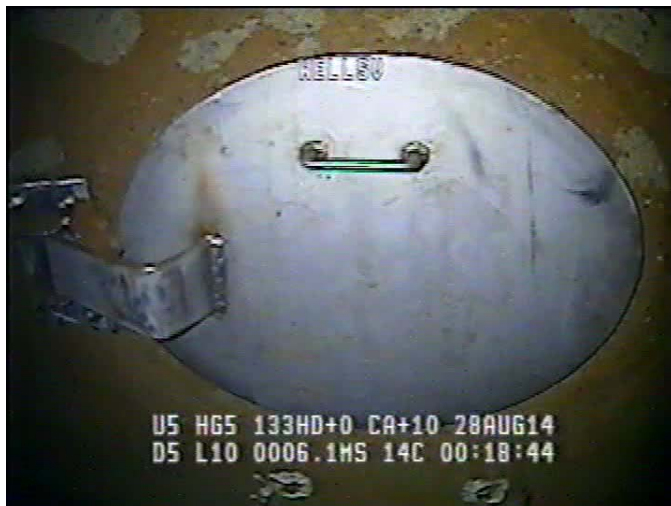
Detail view of wall coating in the middle third of the tank. Note the exposed aggregate.

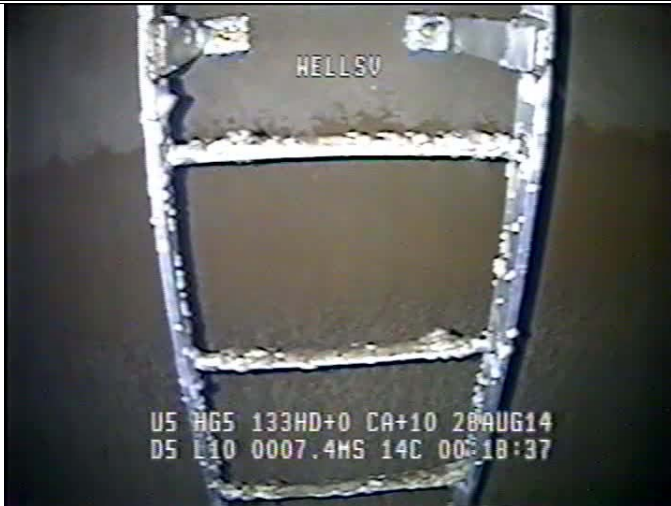
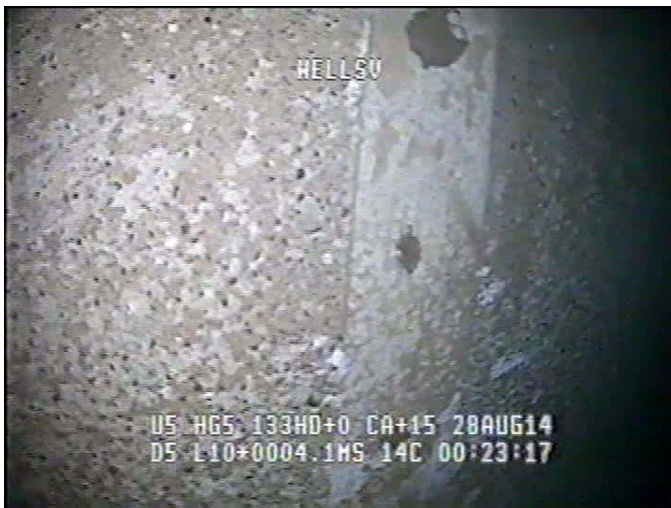
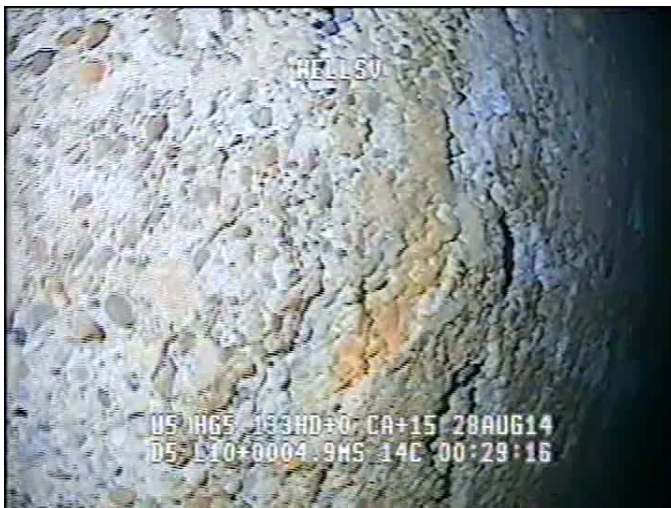
Isolated rusting in the middle third of the tank.

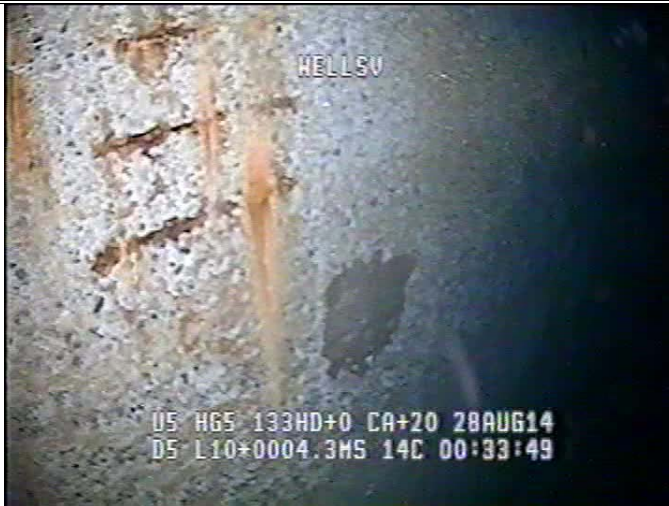
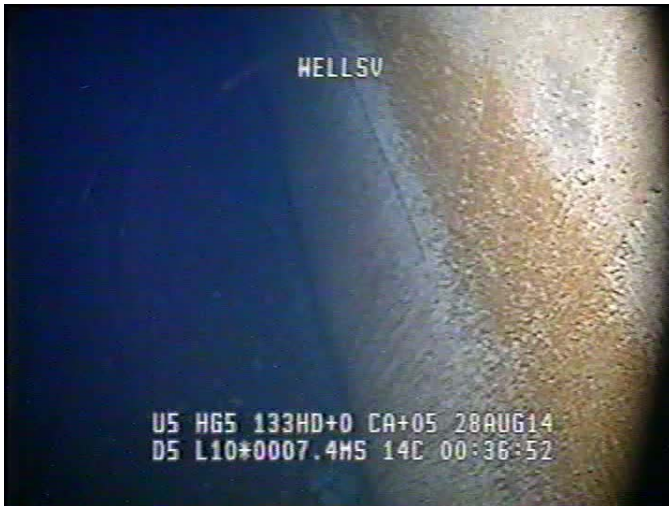
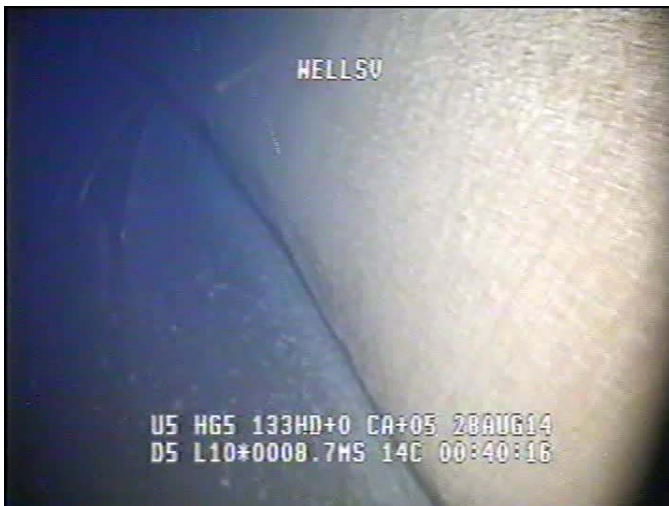
View of the inflow floor penetrator pipe. The pipe appears to be good condition.

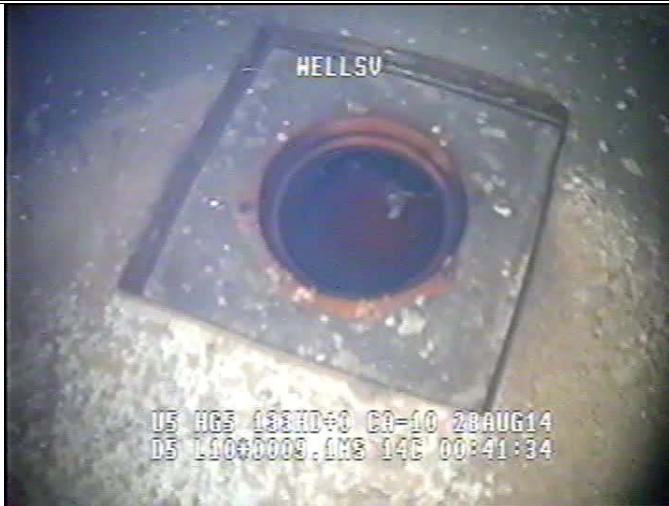
View of the outflow floor penetrator pipe. The pipe appears to be in good condition.

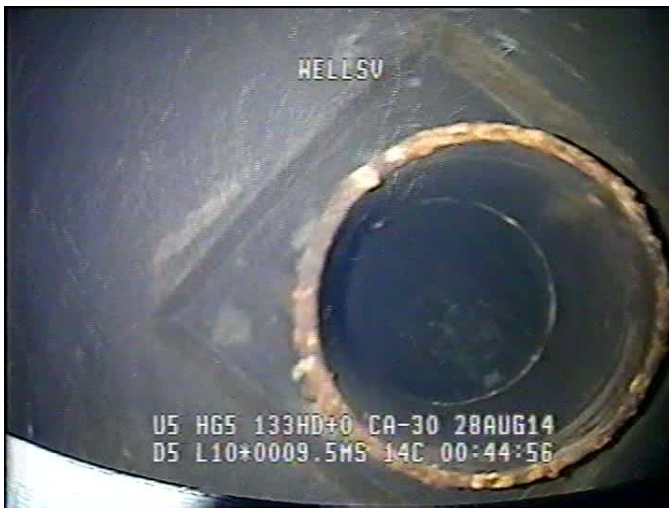
View of the second inflow floor penetrator pipe. The pipe appears to be in good condition.

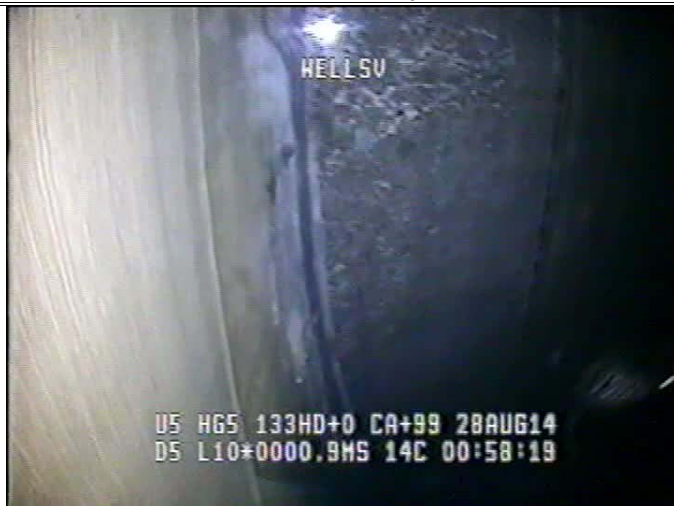
View of the tank wall intersection with the tank roof. The roof appears to be in good condition.

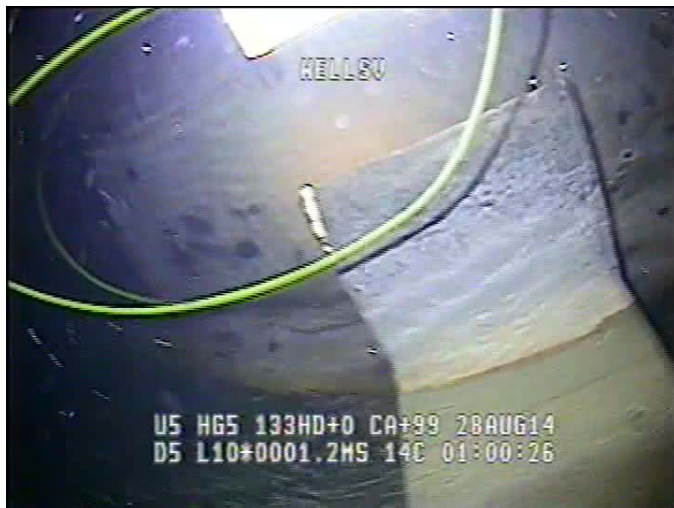
View of the top of the overflow. The overflow appears to be in good condition.

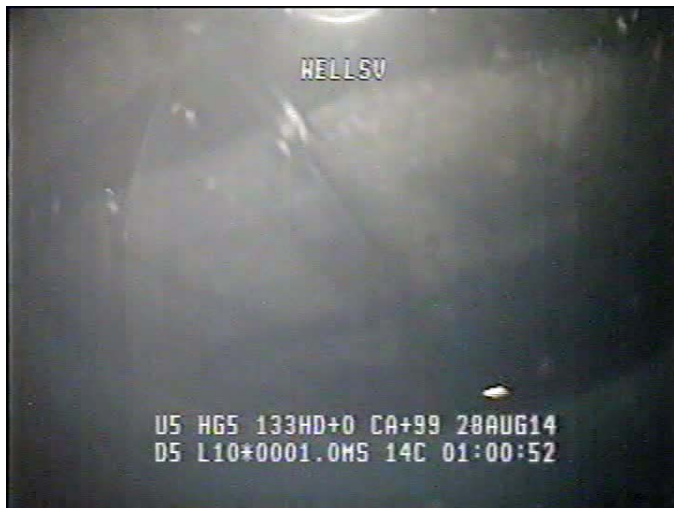
View of the center of the tank roof. The roof appears to be in good condition.
